RECAPP Facility Evaluation Report

Lethbridge Collegiate Institute

B3687A
Lethbridge

Evaluation Company: J.A. Matthew Architect Ltd.
Evaluation Date: June 2 2005
Evaluator Name: Mr. Joe Matthew

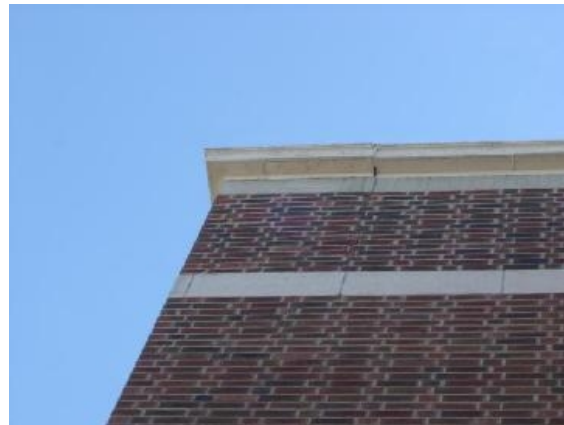
Event: 1949 (Wing D) south east top corner brick has a large crack that extends to the roof parapet that is also separating from the adjacent portion.

Repair the damaged portion of the brick facade, parapet and the roof if necessary.

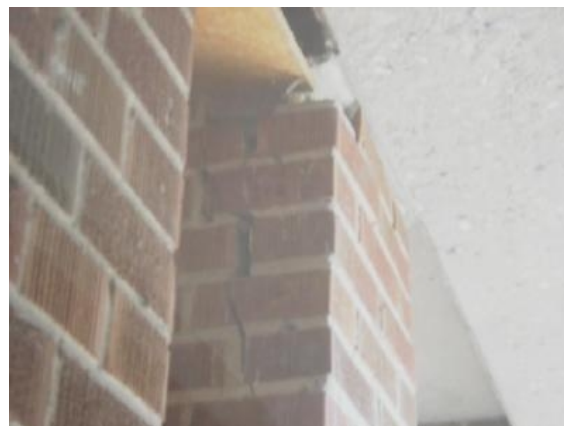
Event: 1949-Wing D-Front entry south side concrete and brick pilasters are cracked.

The pilasters that is holding up the concrete canopy at the front entry is cracked at the top portion and is significantly separating. There is concern about the structural integrity of the pilasters and may need to be investigated by an engineer to determine the extent of the damage.

Repair the damaged portion that is separating as this could pose as a danger for the public using the school. This applies to both the pillars that has sustained damage.

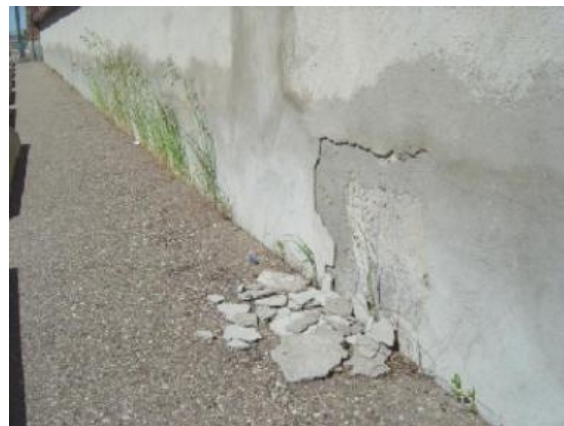
Event: **1957 (Wing B)-Parging is cracked around the perimeter of the building and flaking off.**

The parging on the west side of the building is flaking off. This could allow further damage to the rest of the wall and increase the affected area.

Refinish the wall and restore the protective layer of the wall base on building B west side and repaint to match the existing color. Apoproximately 80 sq.m of area.

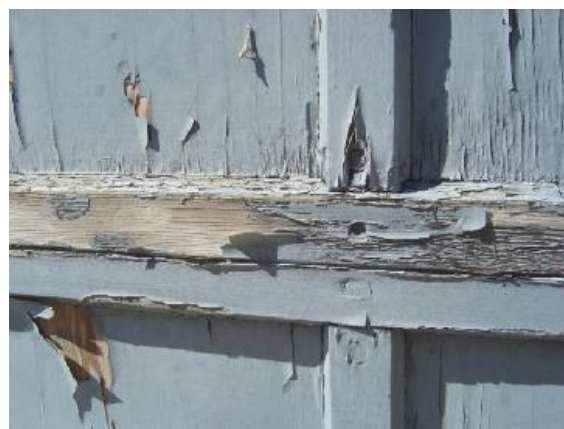
Event: 1949 (Wing F) and 1970 (Wing G)- Wood overhead doos need to be replaced

The doors are in bad shape and need to be replaced.

Replace the old wooden doors with steel roll up doors. There are six bays with doors that are 3m x 2.43m in width.

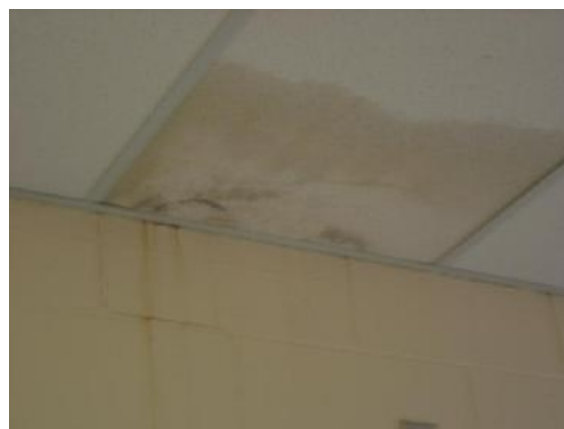
Event: **Replace damaged T-bar tiles throughout the school due to leaks and condensation of mechanical equipment.**

Many of the acoustic ceiling tiles throughout the school have stains and some have water damage that has been left to sag and some have surface mold on them.

Remove and replace damaged tiles throughout the school. Approximately 500 sq.m. of ceiling tiles to be replaced

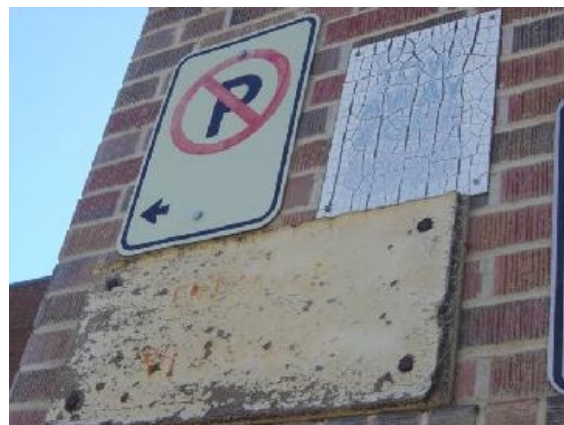
The main school sign at the front of the school is in good condition however there are signs in the parking lot area that have old signs which are no longer legible but are still attached to the building.

Signs around the perimeter of the school particularly in the parking areas need to be replaced. Old ones need to be taken down for efficient way finding.

Replace and remove old signs.
